AERIAL PHOTOGRAPHIC ANALYSIS USN SUPPLY CENTER - CHEATHAM ANNEX

Williamsburg, Virginia

TS-PIC-9803364S
May 1998

D. R. Williams
Environmental Services Division
Lockheed Environmental Systems & Technologies Co.
Las Vegas, Nevada 89119

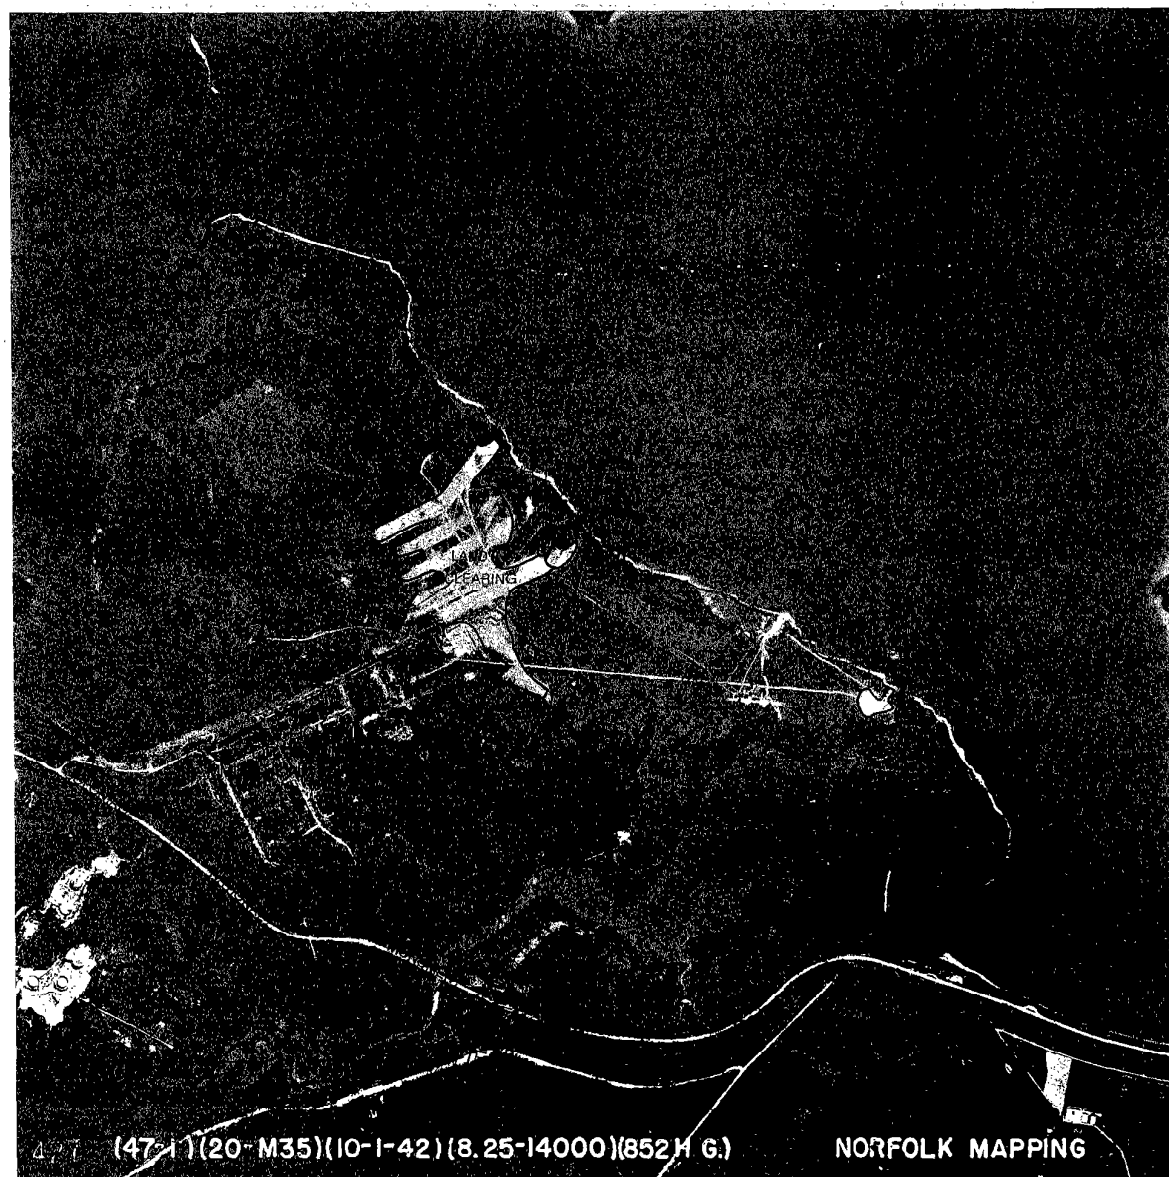
Figure 4. USN Supply Center - Cheatham Annex, eastern portion, October 1, 1942. Approximate scale 1:20,120.

AOC 1 (Landfill Next to Incinerator) is visible adjacent to a small tributary that flows into the York River. Solid waste (SW) is present on both banks of the tributary. In 1942, land is being cleared for initial construction of the USN Supply Center. In the far eastern portion of the site is a deposit of fill (FL).

Penniman Ammunitions Plant features and surface drainage patterns not visible in 1937 in the extreme eastern portion of the site are identified on this 1942 photograph.

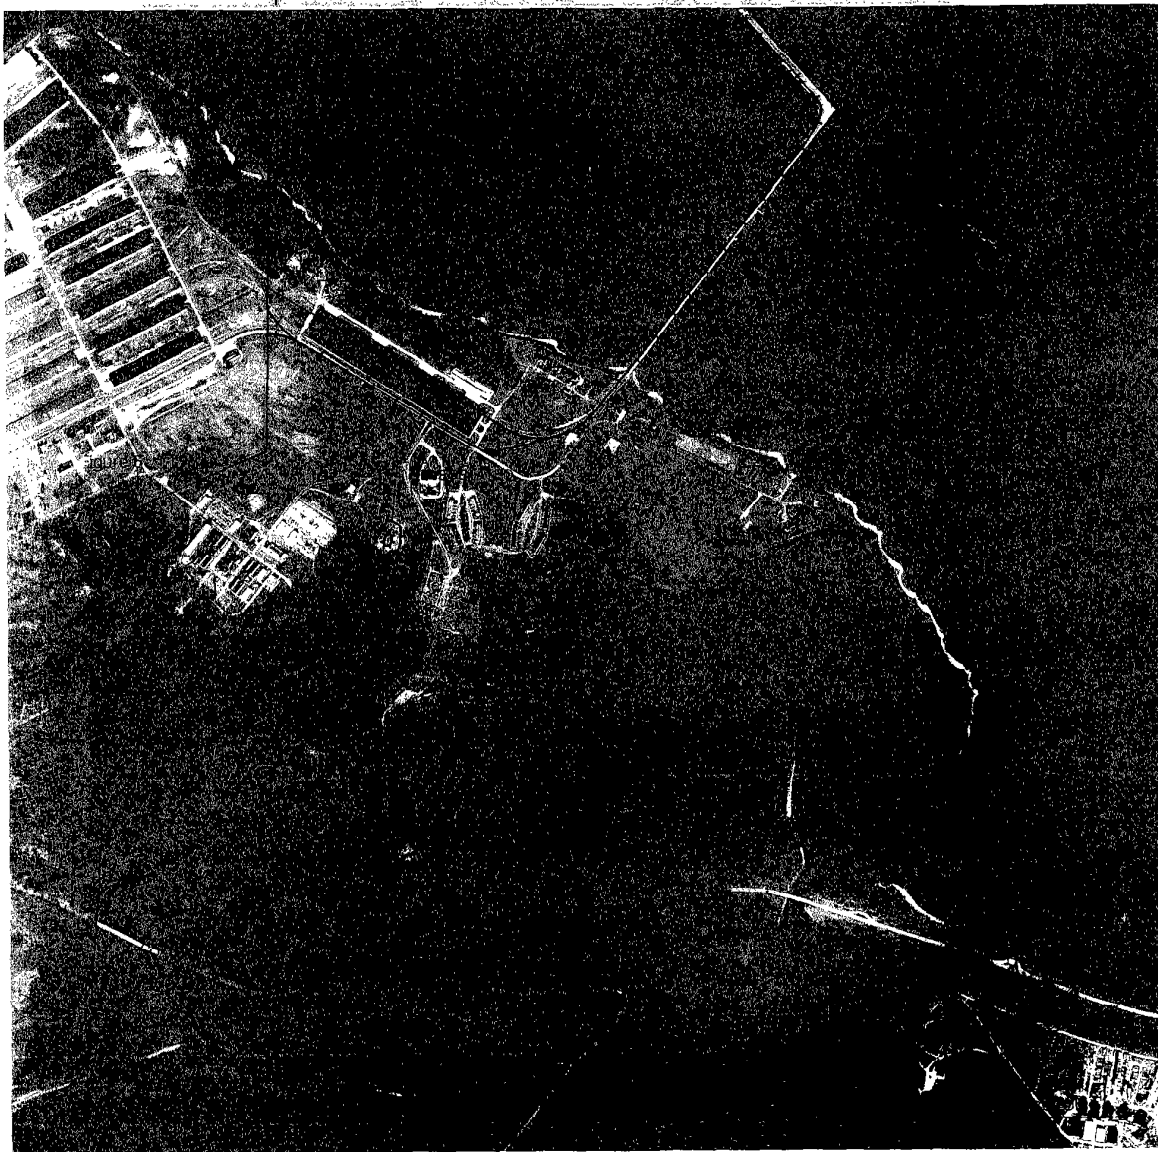
Light- and dark-toned solid waste are visible at AOC 1.

On the north shore of Penniman Lake is a partially revegetated deposit of fill. A possible outfall (OF) is visible to the west.

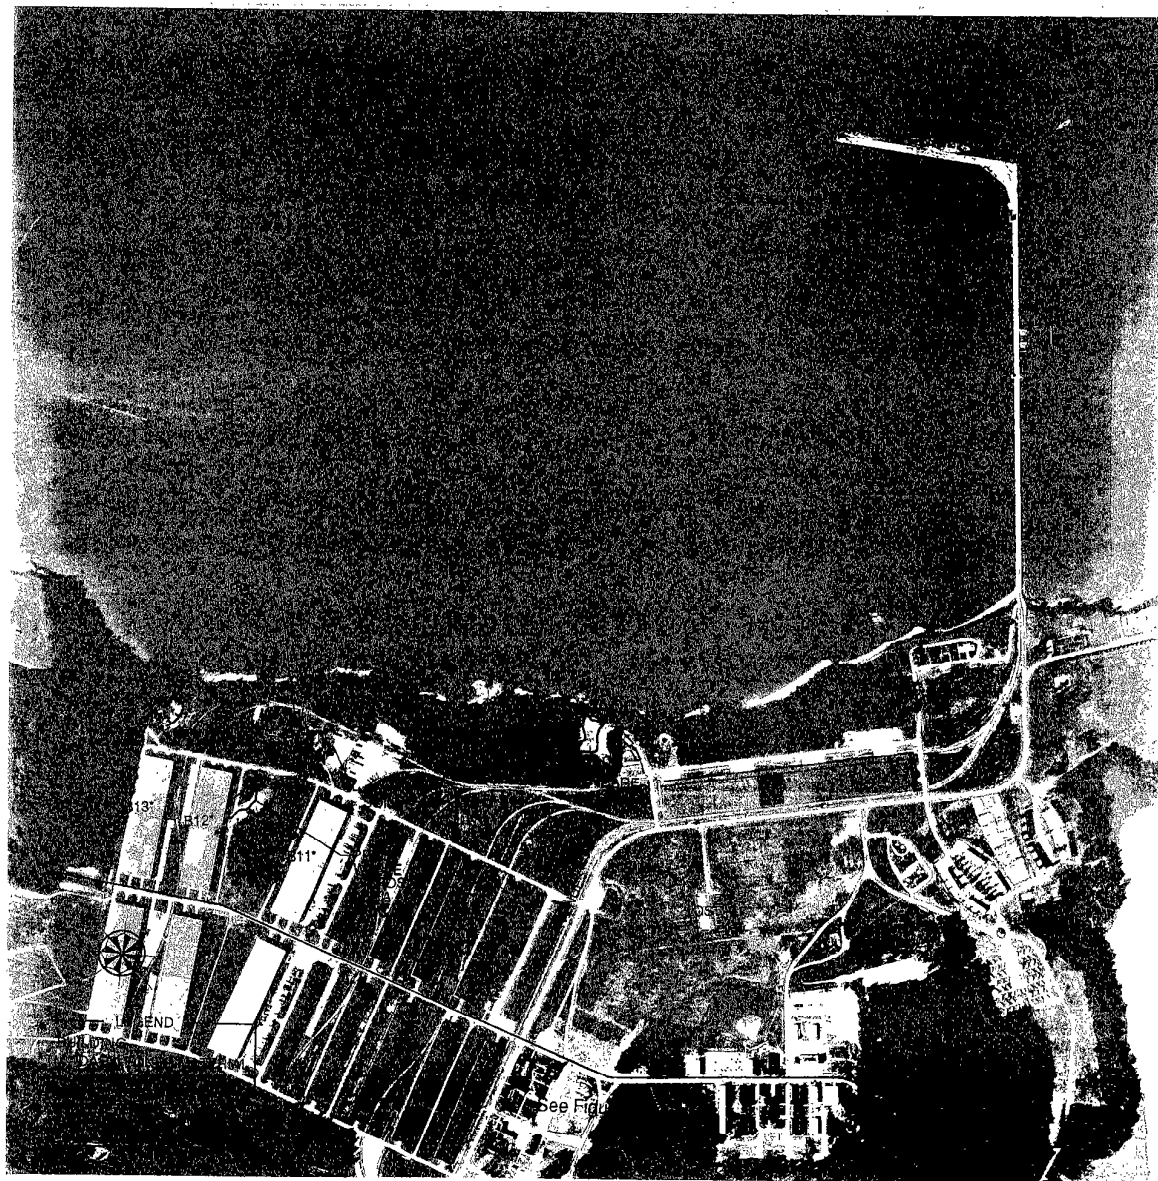
The road and railway infrastructure at the site is essentially completed. Adjacent to Building 13 (B13) is a partially revegetated excavation. South of Building 12 (B12) is a possible disposal area consisting of bare soil. Several open storage areas (OS) consisting of crates and other stored objects are present in this large building complex. At the south end of the building complex is a small stain (ST) at an open storage area.

East and north of Building 40 (B40) are areas of staining. North of Building 40 is AOC 2 (Contaminated Food Disposal Area) which consists of a revegetated mound and a trench (TR). West of Building 40 revegetated disturbed ground (DG) is evident. A drainage channel trends through the disturbed ground area toward Cheatham Pond. To the southwest two small deposits of dark-toned material (DTM) are visible. At AOC 11 southeast of Sanda Avenue is a small enclosure and several small unidentified objects. Drainage from AOC 11 flows into Penniman Lake where a small excavation is noted. Two possible disposal areas (and possible solid waste deposits) are seen to the west of AOC 11 and to the north is a large area of staining.

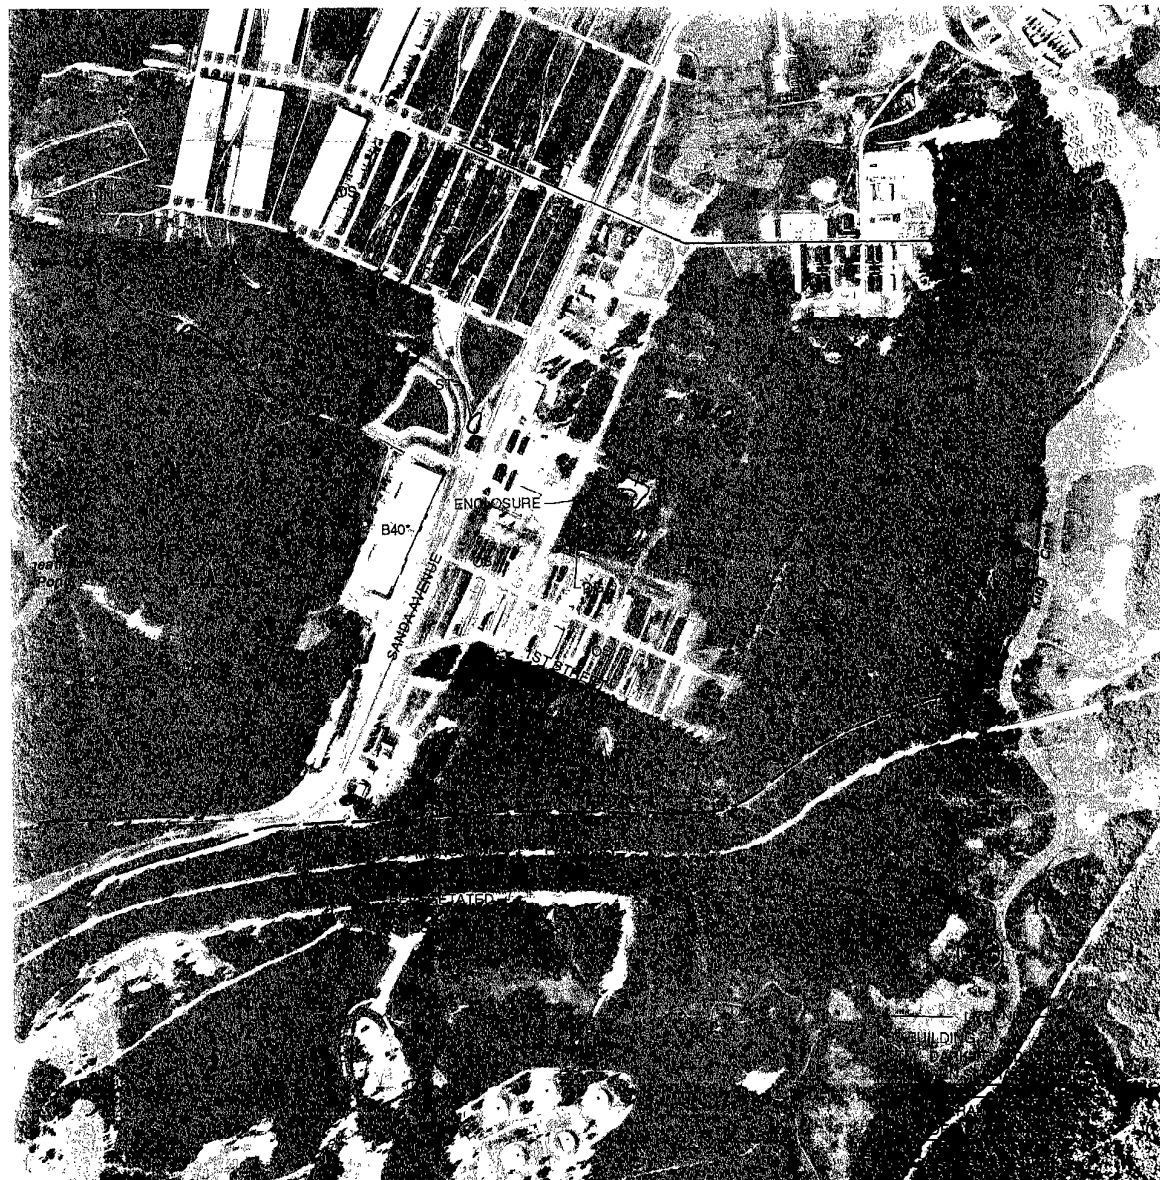
JUNE 27, 1960 (FIGURE 8)

The areal extent of AOC 1 has increased compared to 1955 and dark-toned material is visible.

A possible waste disposal area is noted northeast of Building 11 (B11). An access road and bare soil are present. Surface drainage flows through the area and eventually into the York River. East of Building 12 is the possible waste disposal area seen in 1955. No revegetation has occurred since 1955 indicating probable continued use of the area (AOC 4; Medical Supplies Disposal Area) for waste disposal.

Grading marks are observed west of Building 14. Northeast of Building 40, staining continues to be present adjacent to the railroad tracks. To the southwest of Building 40, dark-toned material is still evident. Southeast of Sanda Avenue at AOC 11 the enclosure is present as in 1955. Bare soil is also present at AOC 11 and to the south. A small area of disturbed ground is present near AOC 11. Solid waste is present at one of the old possible disposal areas (seen in 1955) southwest of 1st Street.

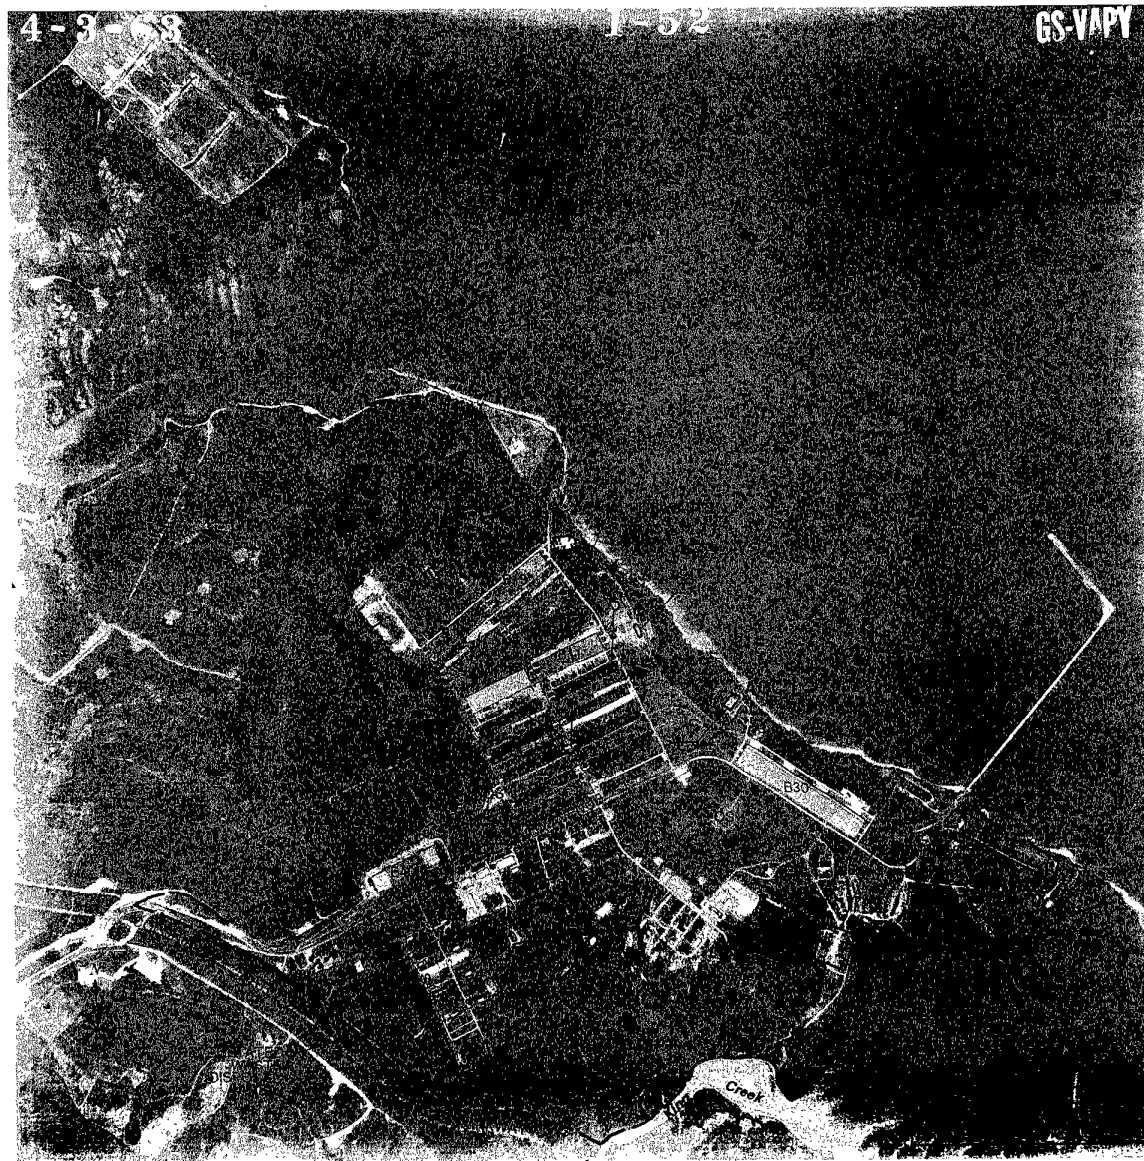
APRIL 3, 1963 (FIGURE 9)

The areal and vertical extent of solid waste at AOC 1 is larger compared to 1960. Northwest of AOC 1 is a revegetated mound (MM) of waste material where bare soil was noted in 1960. Mounded material is also visible to the south in the nearby drainageway. At AOC 4 southeast of Building 12, revegetation has not occurred since 1960. This may indicate continued waste disposal may have occurred. A small access road leads northwest from Building 14 to a shallow trench (TR) filled with liquid. This is the reported location of AOC 8 (Landfill near Warehouse 14). Staining persists northeast of Building 40 at the railroad tracks. Southeast of Sanda Avenue at AOC 11 a stain and two deposits of solid waste are noted. Another possible waste disposal area is seen south of AOC 11 at the end of an access road in a wooded area. Southwest of 1st Street the waste disposal area and the possible waste disposal area first seen in 1955 are completely revegetated.

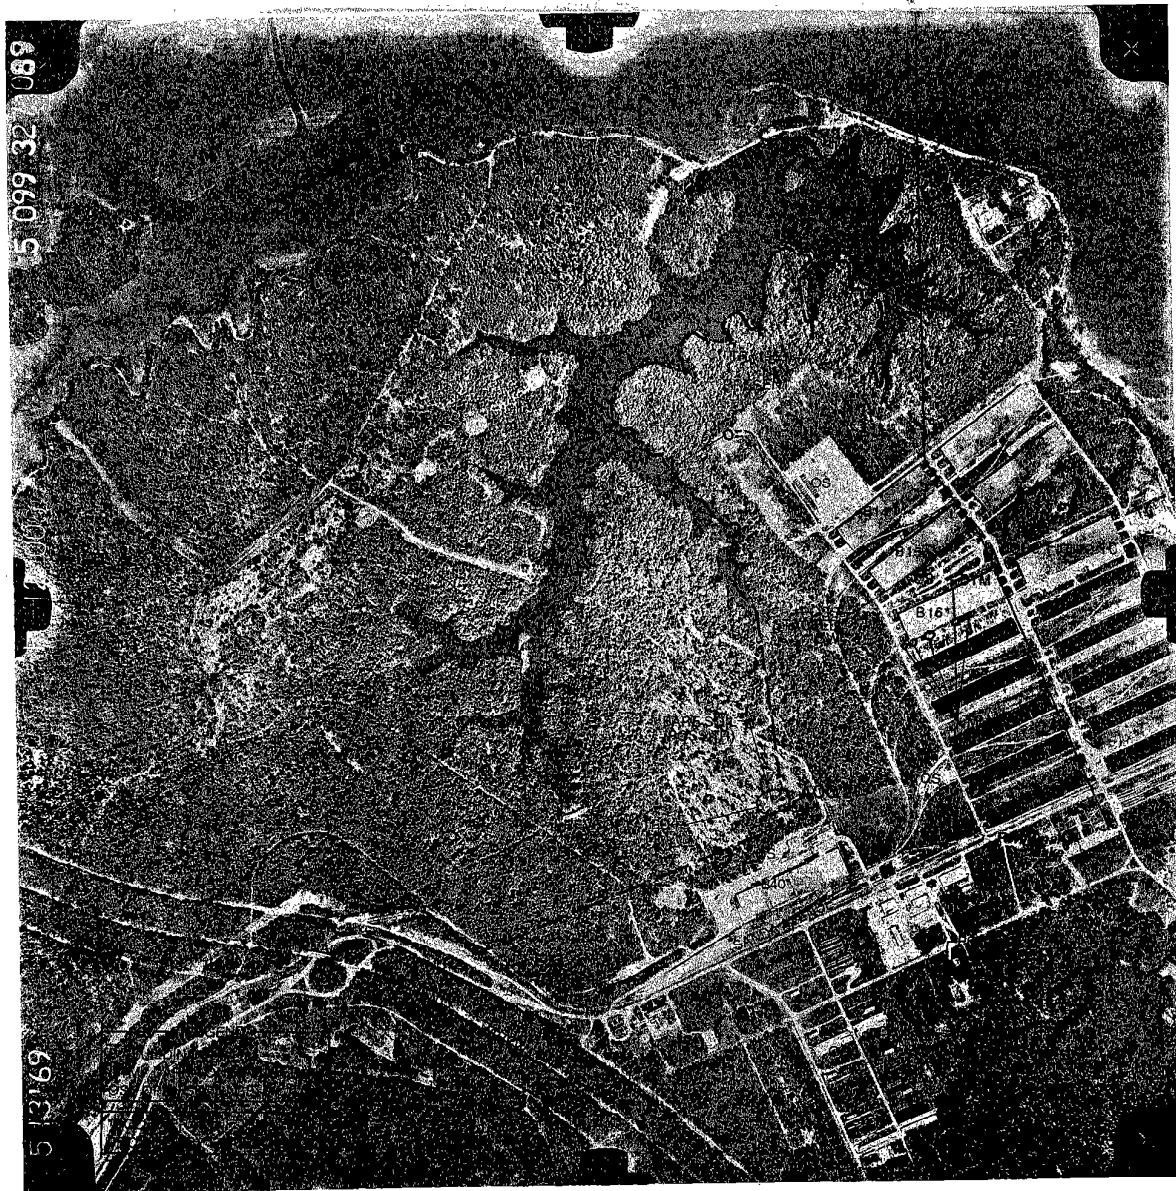
MAY 13, 1969 (FIGURE 11)

Additional solid waste has been deposited at AOC 1 and the areal extent has increased since 1963. Standing liquid is evident at a small facility to the south. The standing liquid appears to flow into Penniman Lake. A large deposit of revegetated material is present next to Building 11. In 1963 a smaller amount of revegetated material was present. The areal extent of the excavation next to Building 13 has increased since 1963 and staining is also seen. This indicates probable waste disposal activity. AOC 4 is now revegetated indicating that probable waste disposal activities ceased at some point between 1960 and 1969.

Northwest of Building 14 the shallow trench seen in 1963 is not present. To the southwest is a small deposit of possible solid waste which is located at the end of an access road that originates near the vicinity of Building 14. Possible stacked solid waste is present at the east corner of Building 15. Five small deposits of material (one of which is dark-toned) are seen on the southeast side of Building 16. AOC 2 is north of Building 40 and consists of revegetated mounded material and bare soil that appears to be a filled trench. The material and trench were first observed in 1955. Possible drums, associated stains, and standing liquid are present at AOC 11.

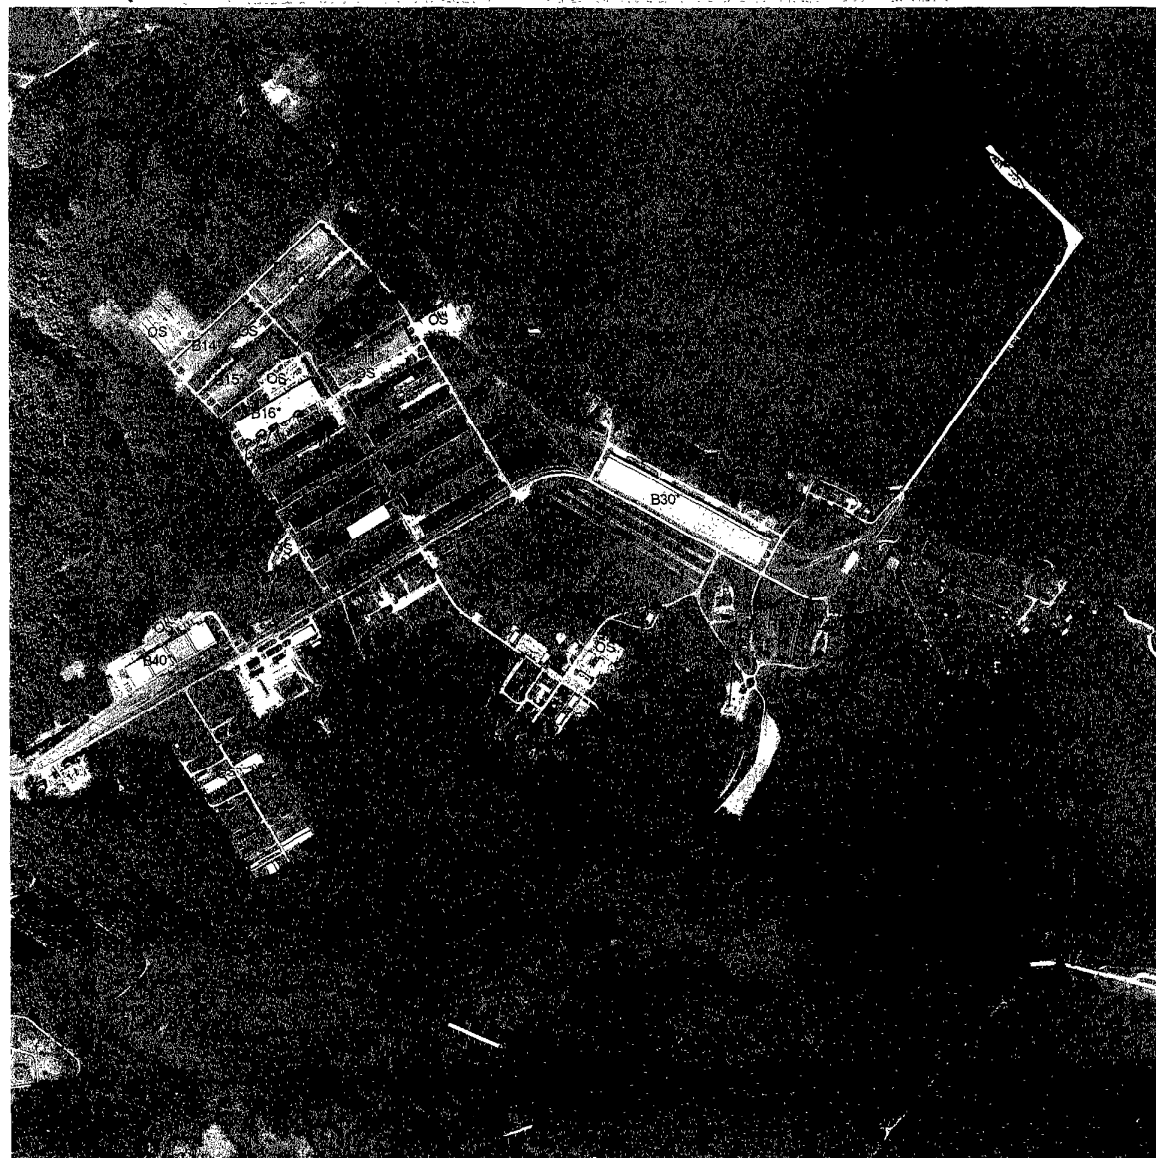
OCTOBER 23, 1975 (FIGURE 12)

AOC 1 is now partially revegetated indicating inactivity since 1969. The revegetated material near Building 11 (1969) is no longer visible; the excavation adjacent to Building 13 is revegetated and inactive; and the possible solid waste northwest of Building 14 (1969) is not visible. AOC 3 (Submarine Dye Disposal Area) is located at the eastern corner of Building 15. Dark-toned material and staining are present. Southeast of Building 16 are four deposits of mounded material where five such deposits had been observed in 1969. Southeast of Sanda Avenue AOC 11 is partially revegetated and appears to be inactive. No other environmentally significant features are observed in 1975.

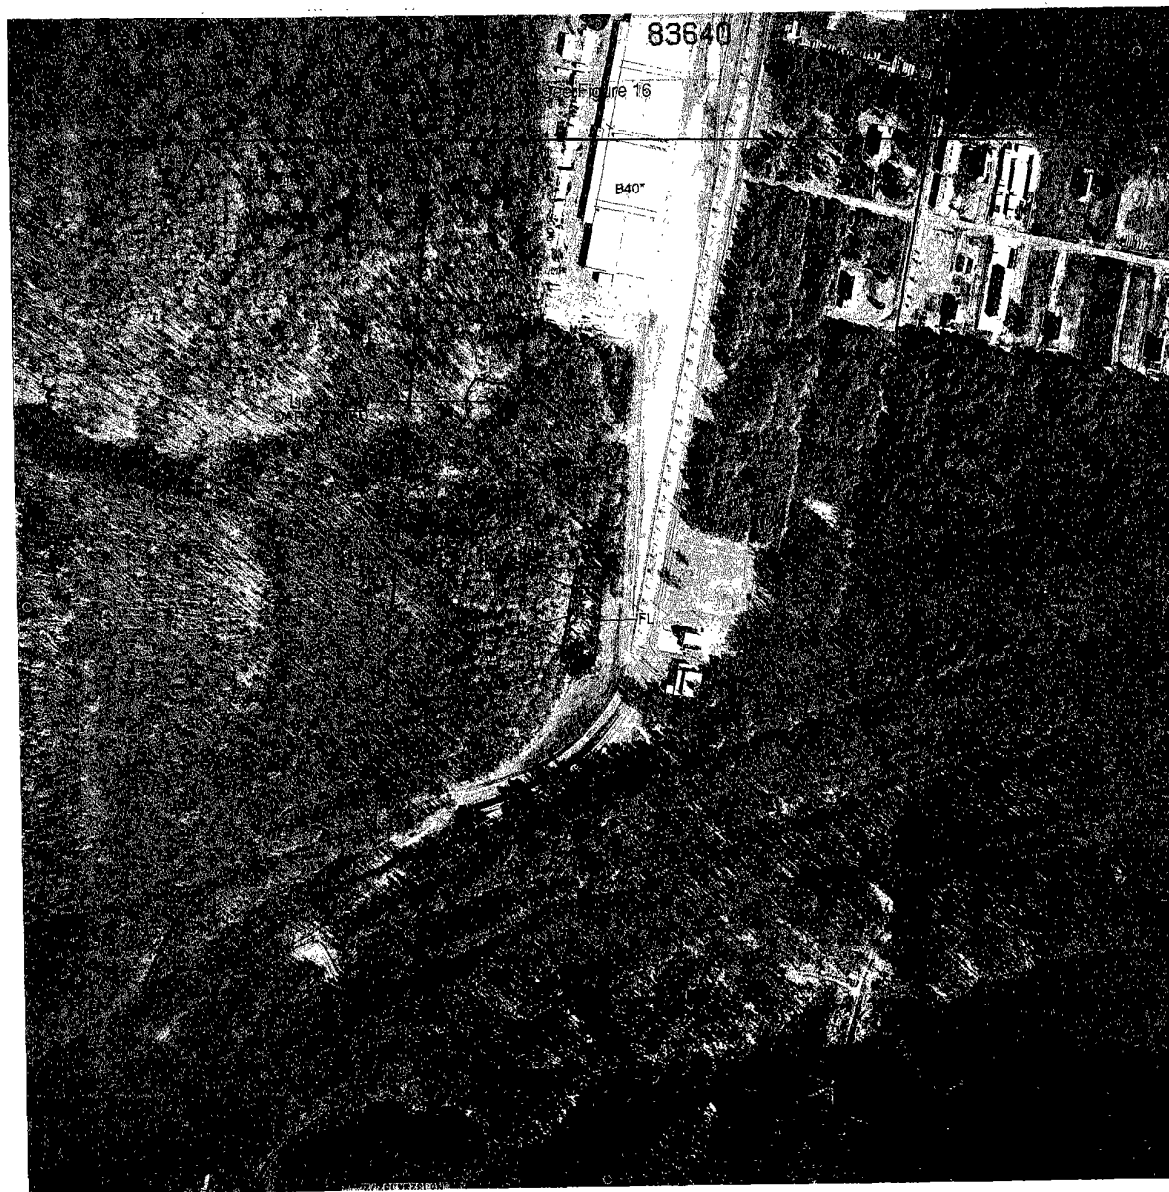
JANUARY 1, 1998 (FIGURE 15)

Adjacent to Building 13 is an open storage area containing shipping containers, crates, propellers, metal framing, eight tanks, nine drums, and numerous small boat hulls. Similar types of stored items are noted next to Building 14. In the field north of Building 14 are numerous small naval boats, metal framing, and large shipping containers. North of the field, land clearing is in progress and a large mound of fill is present.

West of Building 40 is the area of disturbed ground first observed in 1955. The area consists of revegetated disturbed ground and a small mound of light- and dark-toned solid waste. Bare soil is evident next to the solid waste which possibly indicates continued use of the area for waste disposal. An access road leads from Building 40 to the disturbed area. To the southwest is a rectangular excavation probably caused by dismantling of the railroads in this area. At the bottom of the excavation are five mounds of fill. Additional fill appears to have been spread on the remainder of the ground surface within the excavation.

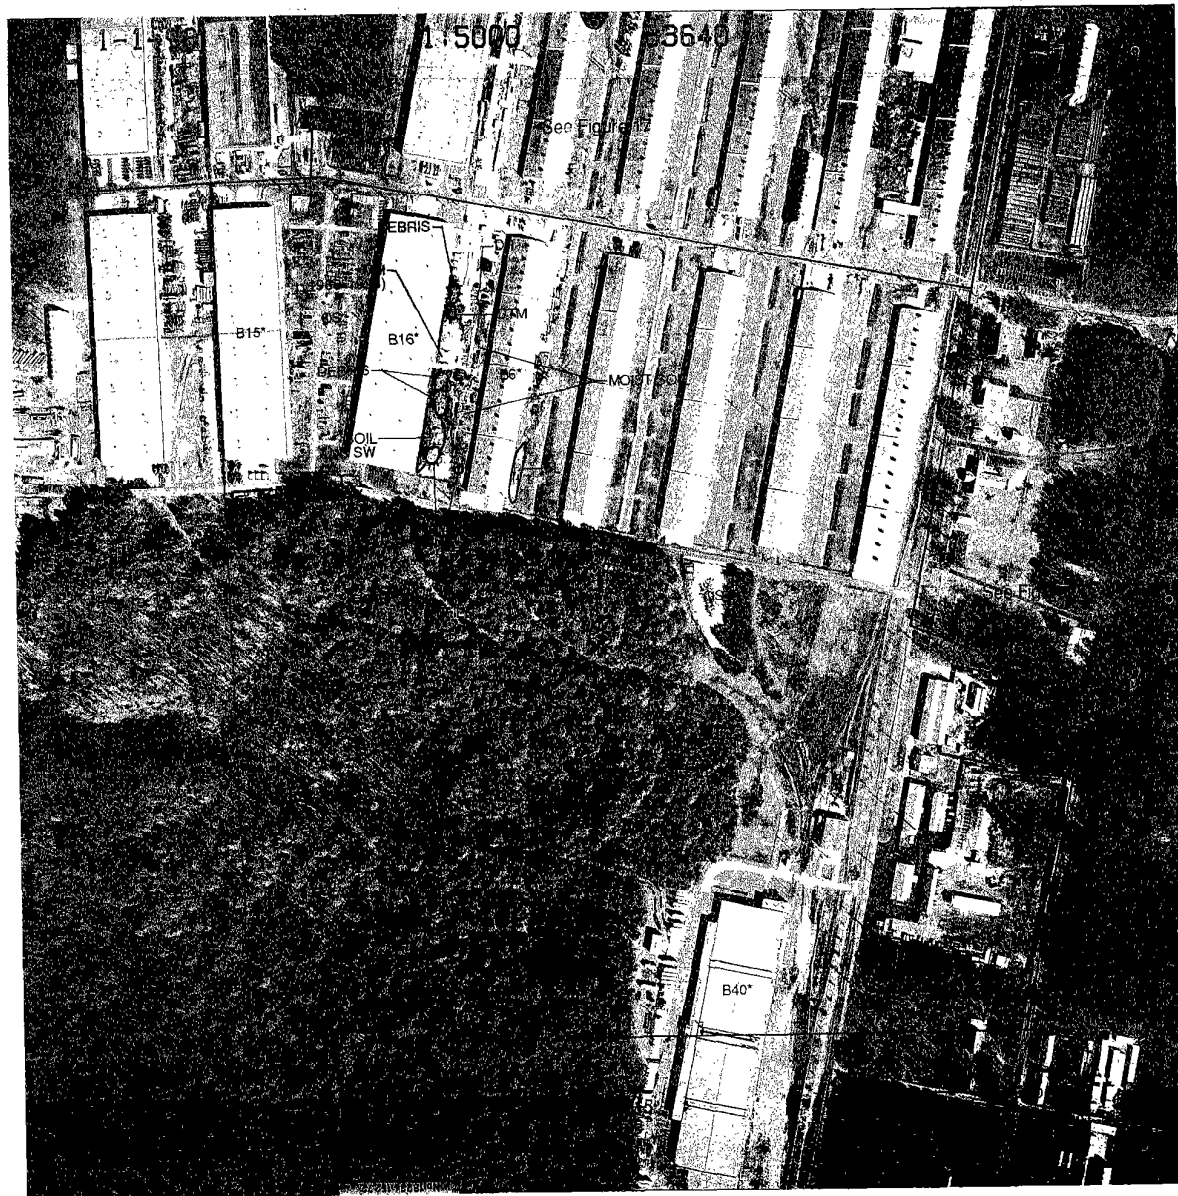
JANUARY 1, 1998 (FIGURE 16)

Five piles of debris, one of which contains dark-toned material, are present between Buildings 16 and 6. Moist soil and soil mixed with solid waste are also observed. One small accumulation of drums is also present between the buildings. According to background information, AOC 9 was located at the west corner of Building 16, but it is not observed. Fill is present on the southeast side of Building 6 due to removal of railroad tracks in this area. Disturbed ground also due to removal of railroad tracks is seen northeast of Building 40. An old access road leading from Building 40 into an adjacent wooded area probably leads to the old AOC 2 location observed in 1955 and 1969.

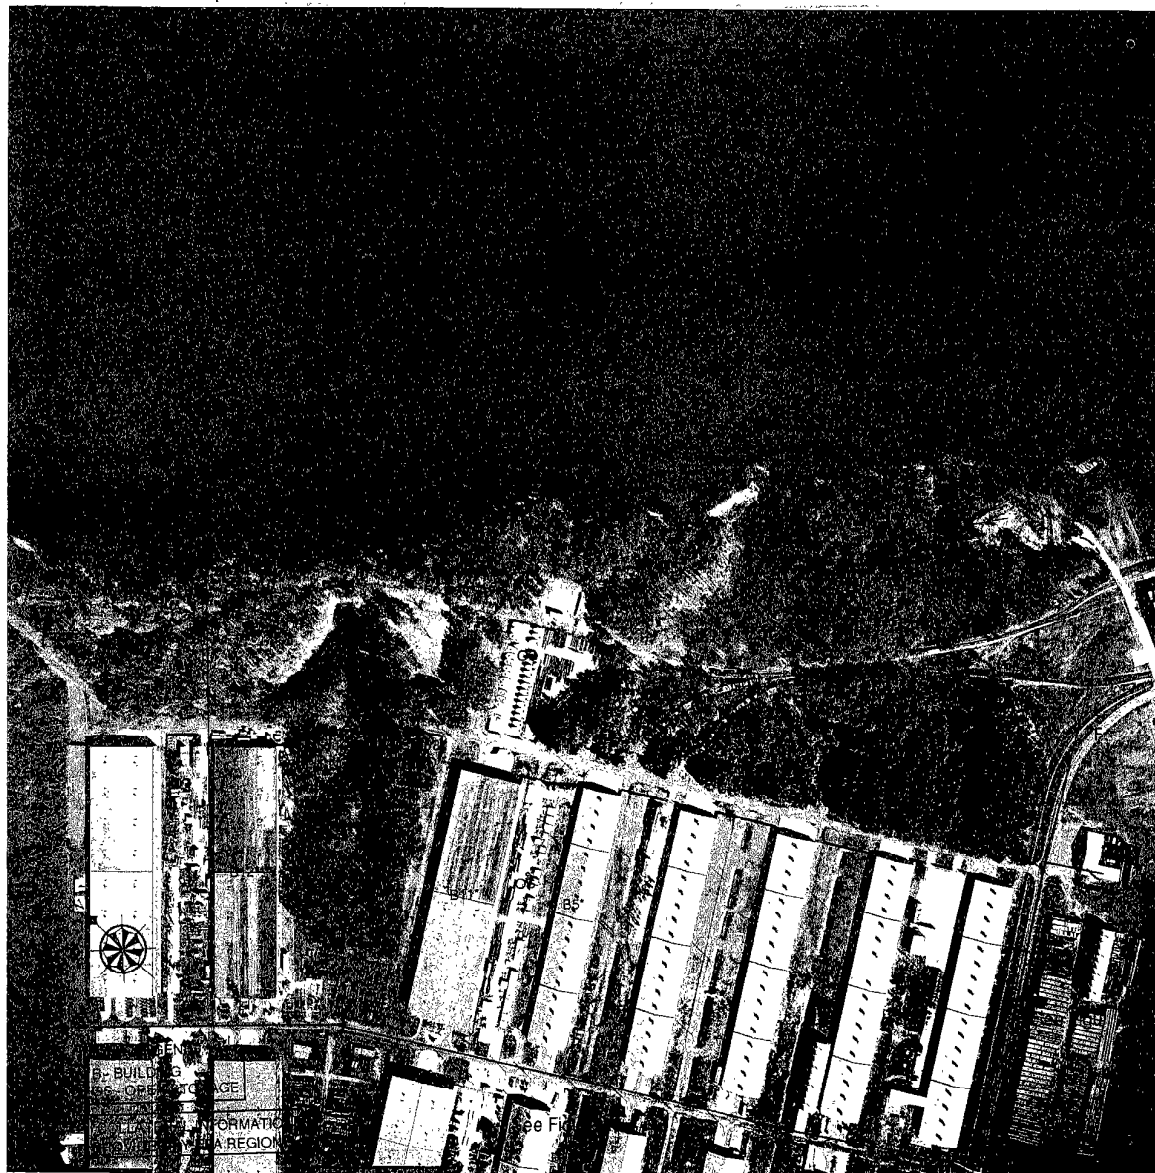
JANUARY 1, 1998 (FIGURE 17)

AOC 1 is partially revegetated and two small areas of standing liquid are present on the bare soil portion of the old landfill. Two open storage areas containing shipping containers and large propellers are present next to Buildings 11 and 5.

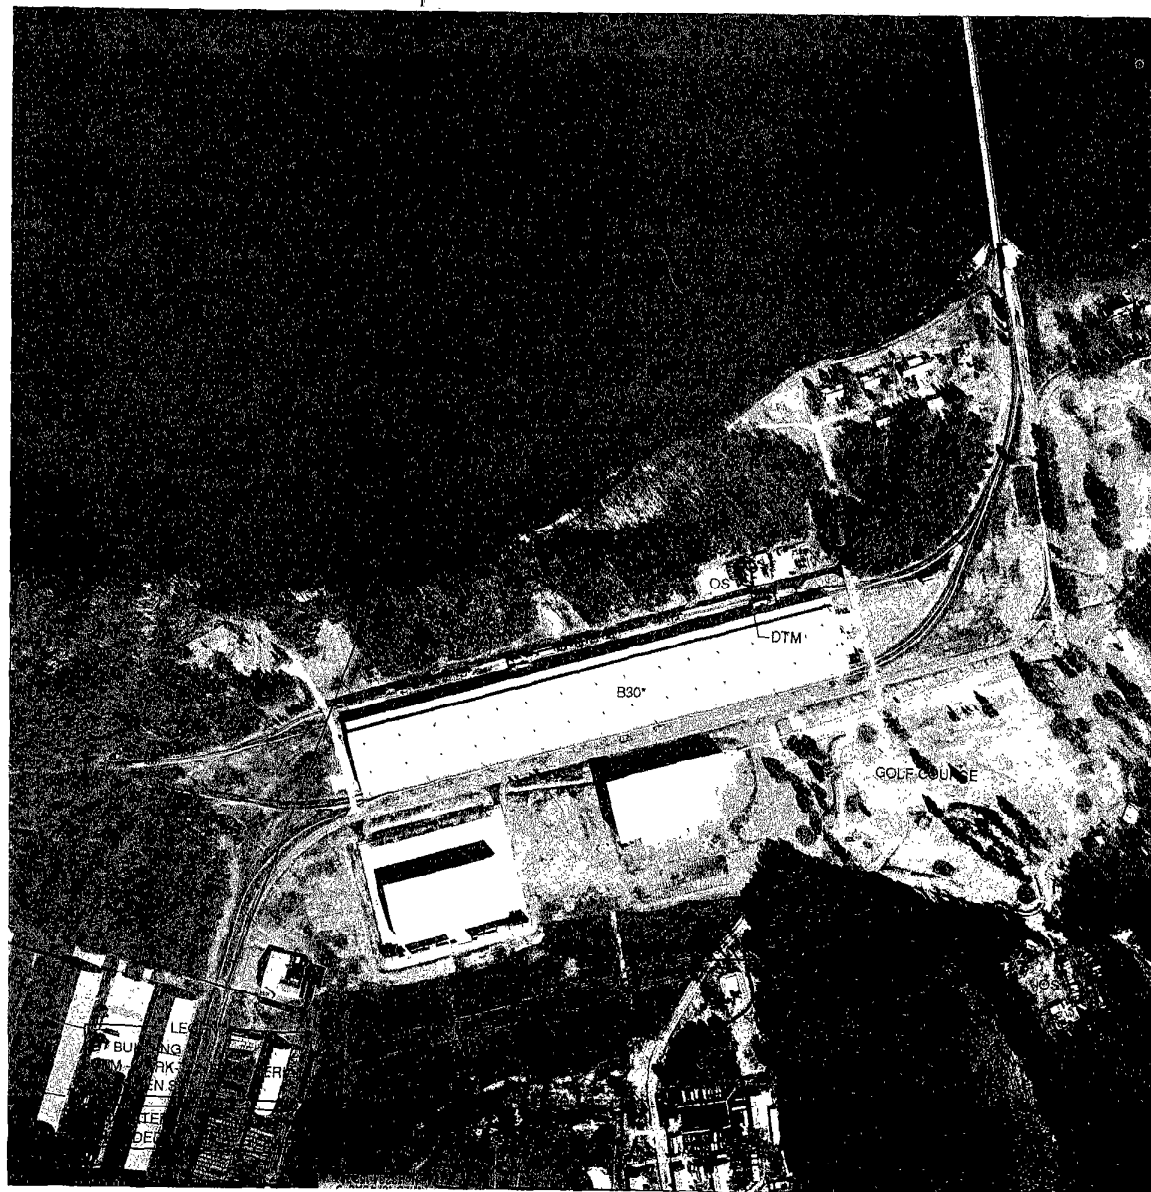
JANUARY 1, 1998 (FIGURE 18)

In an open storage area adjacent to Building 30 is a mound of dark-toned material and a small accumulation of drums. No other environmentally significant features are observed on this photograph.

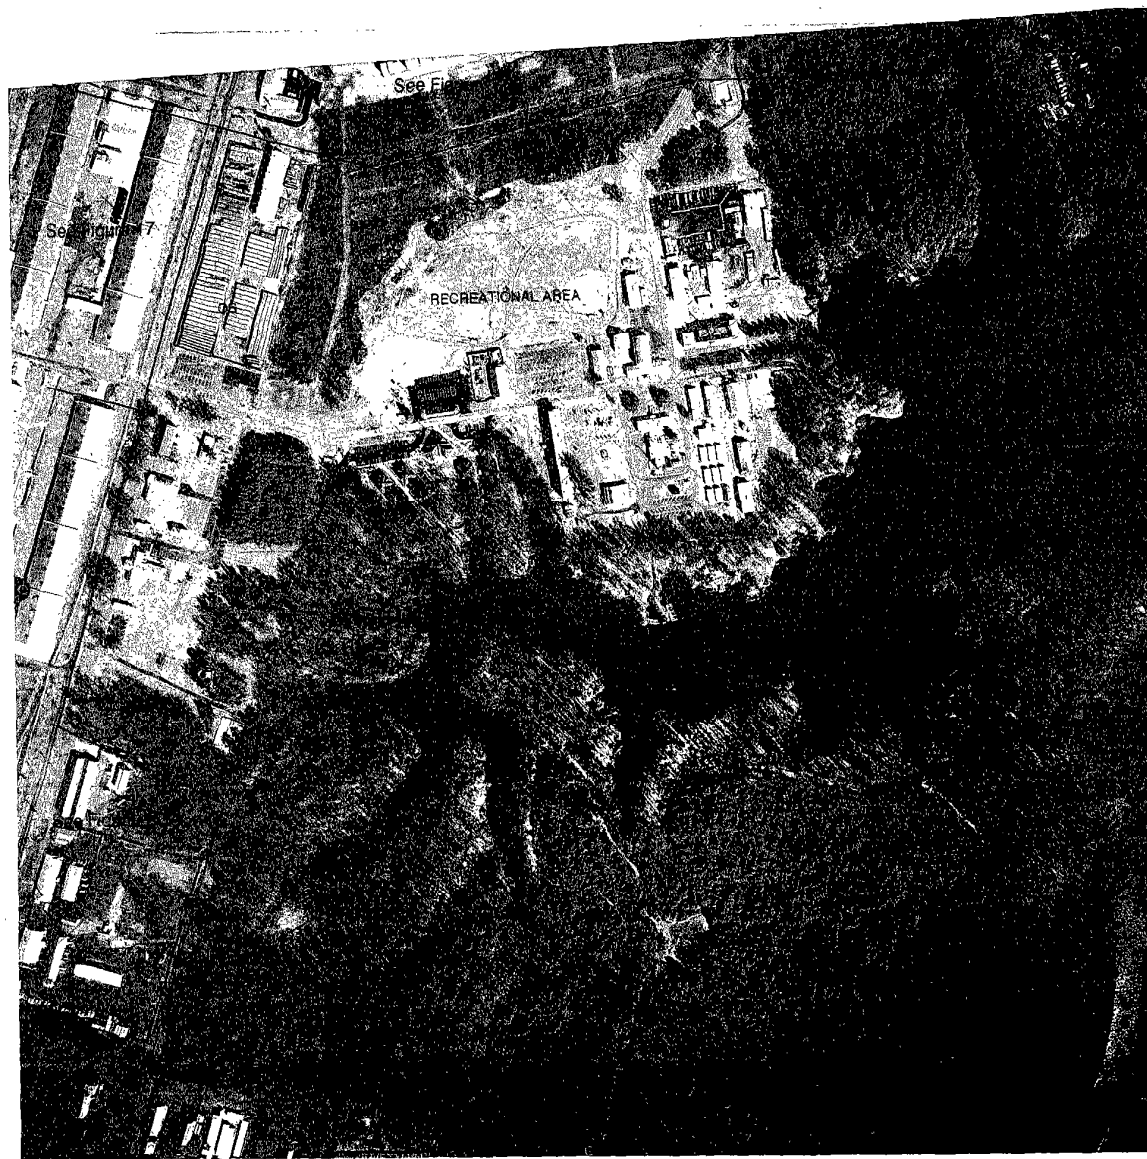
JANUARY 1, 1998 (FIGURE 19)

A large grouping of buildings, an open storage area, and a recreational area are seen adjoining Penniman Lake. At AOC 11 the partially revegetated enclosure is visible due to excellent photographic resolution. Bare soil and standing liquid are also present. According to background material, AOC 5 is located immediately to the west of AOC 11 and AOC 6 is located to the west of the large open storage area; however, neither AOC is observed.

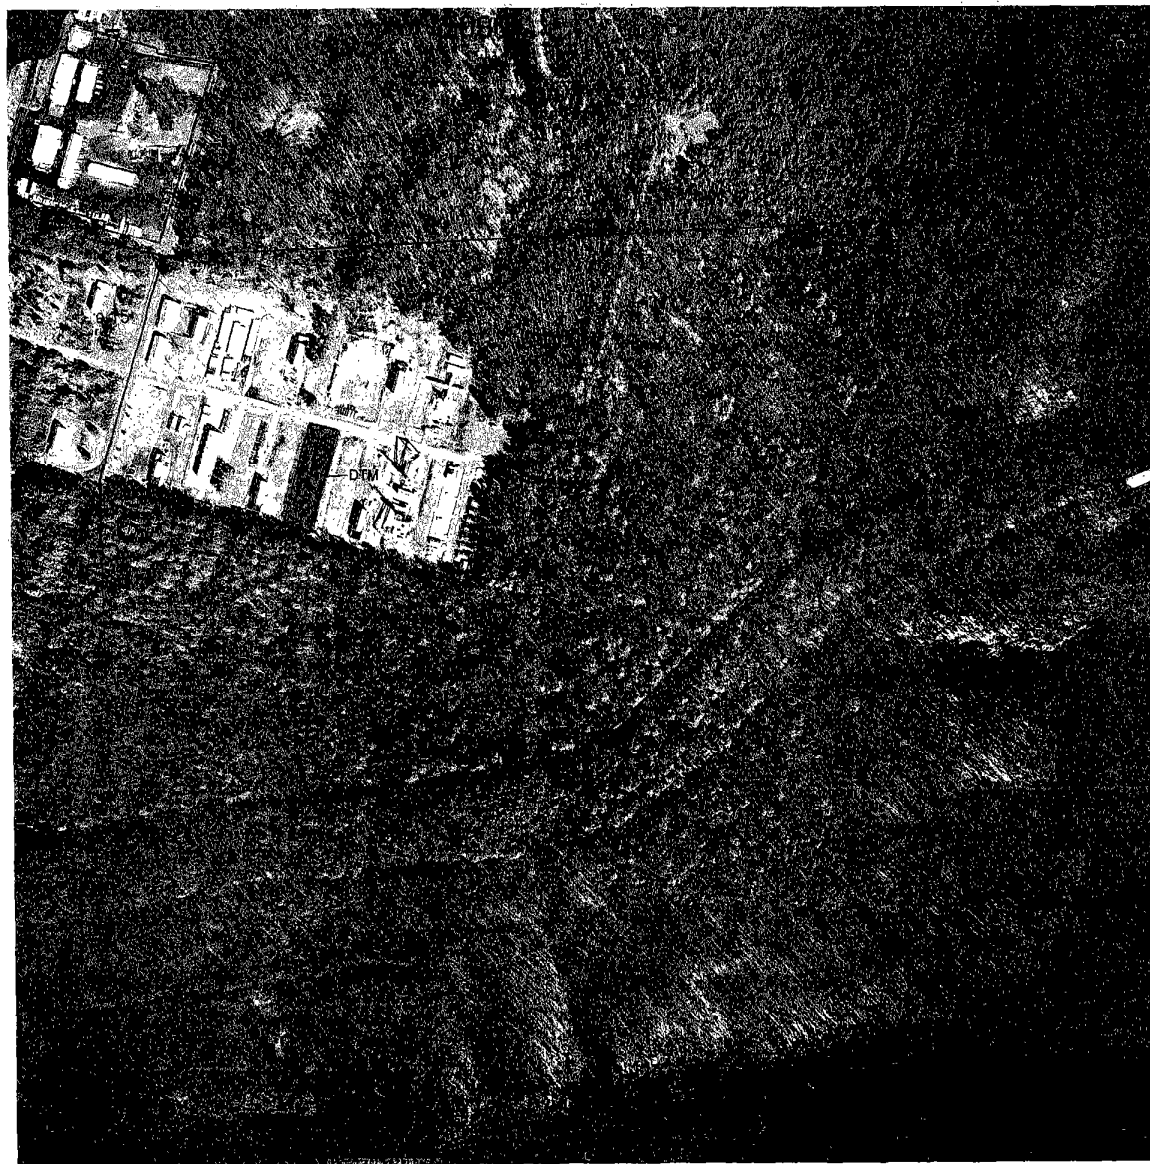
JANUARY 1, 1998 (FIGURE 20)

The large deposit of dark-toned material appears as it did in 1989. To the southeast a small amount of mounded material is noted. According to collateral information, AOC 10 was located directly southeast of the dark-toned material in a wooded area, but it is not observed.

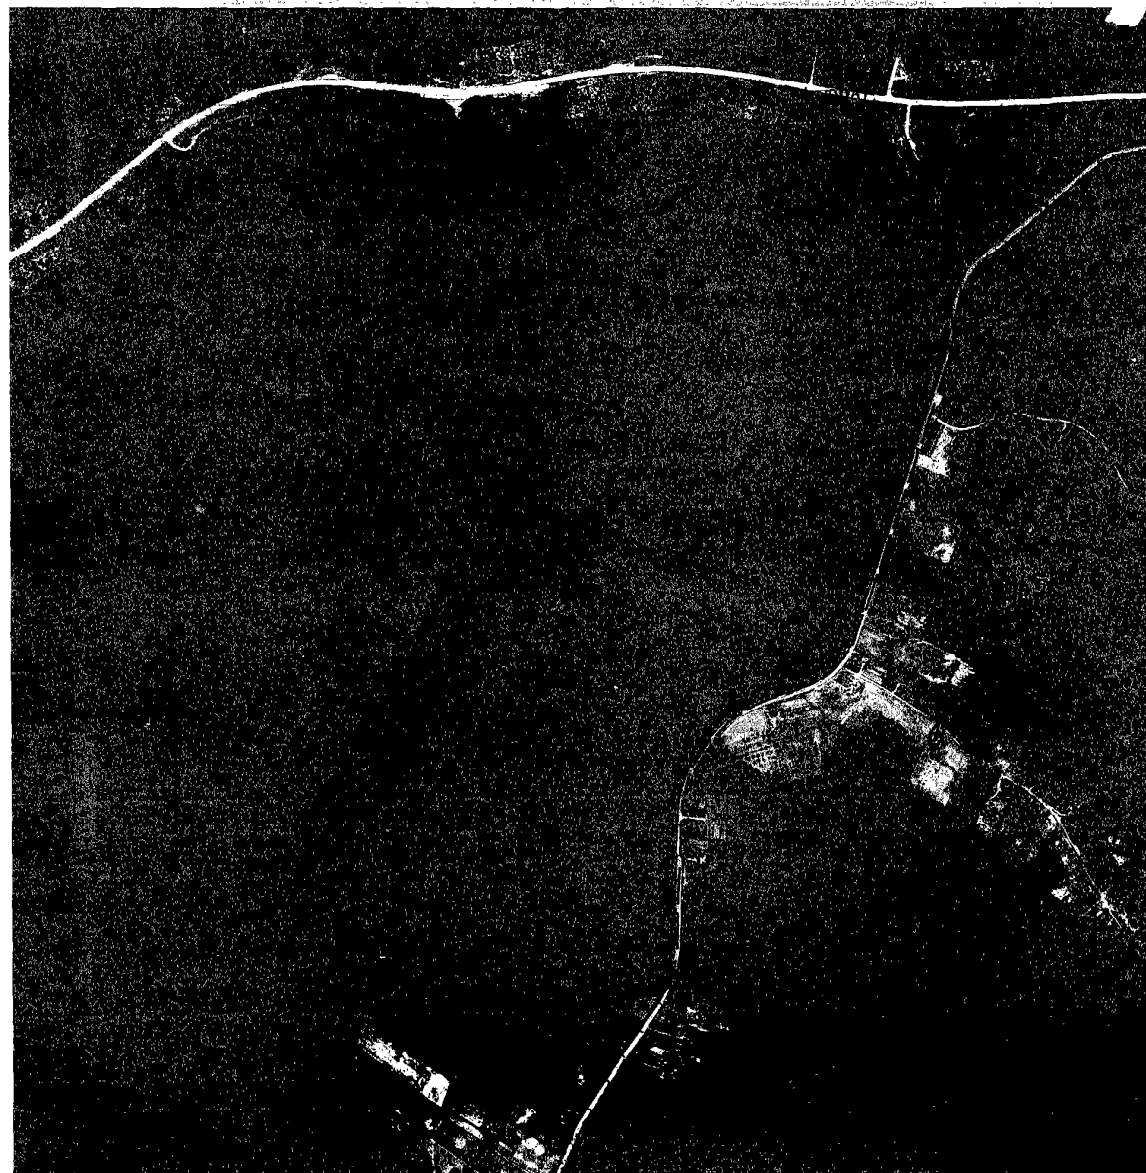
APRIL 17, 1937 (FIGURE 21)

The future location of the western portion of the USN Supply Center consists of forestland and Jones Millpond, a large reservoir.

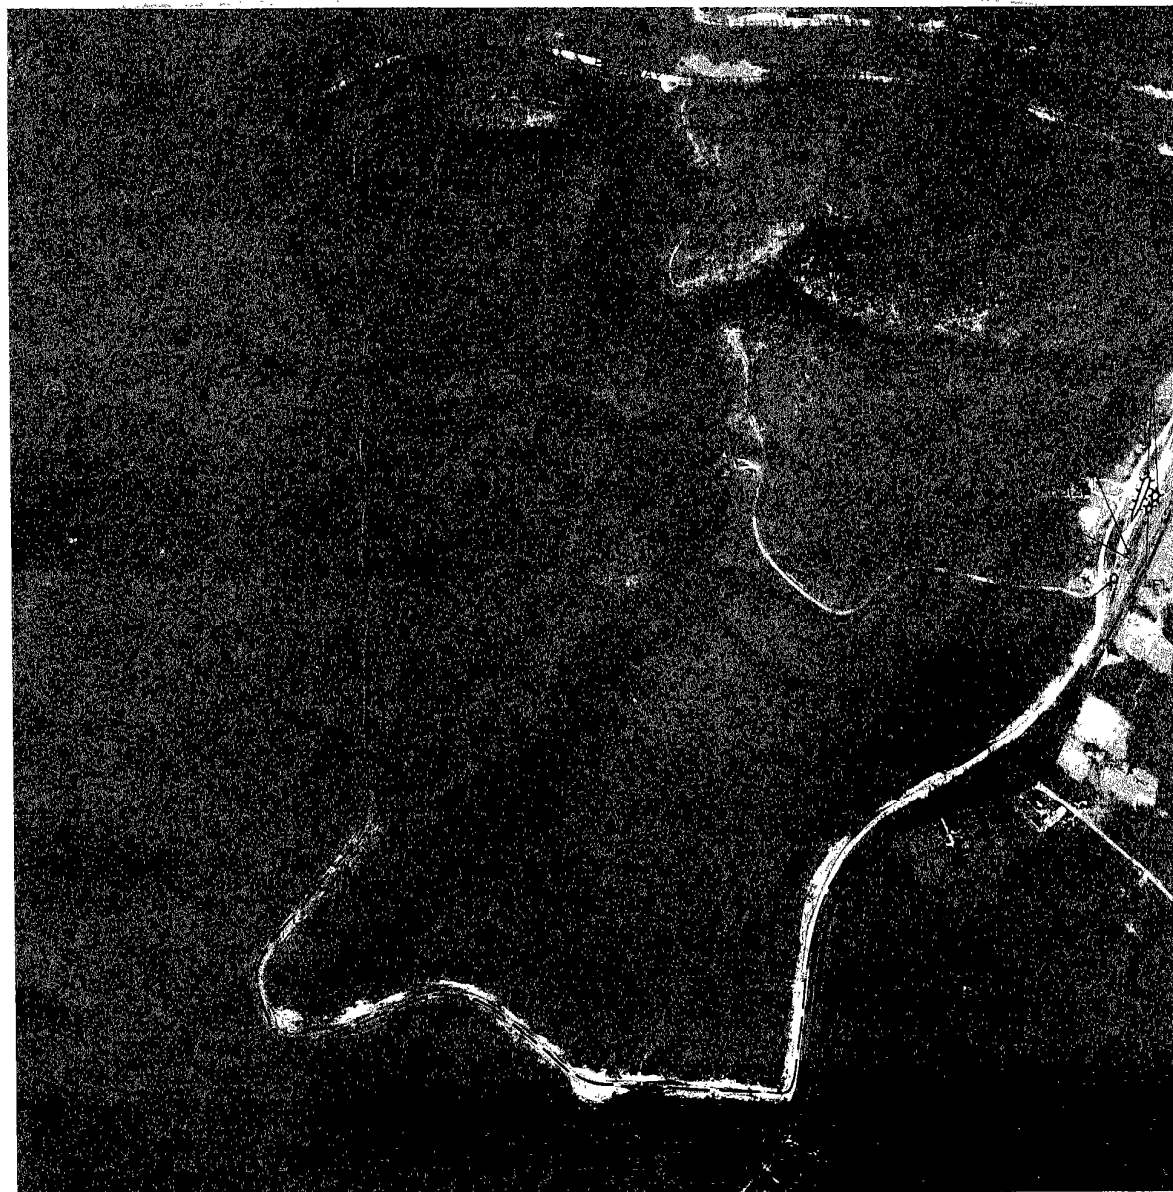
NOVEMBER 21, 1955 (FIGURE 23)

Three mounded deposits of fill are noted at the north end of the small railyard. To the south two railcars and a water tank are present. A small dark-toned mound of material is present at AOC 12 (Disposal Site near Water Tower).
